External Abrasion Caused by Leakages in Potable Water Distribution System Pipes

Daniela Rojas¹; Kevin Vargas²; Andrés Cortés³; Sebastián Rocha⁴; Pablo París⁵; Viviana Riveros⁶; and Juan Saldarriaga, M.ASCE⁷

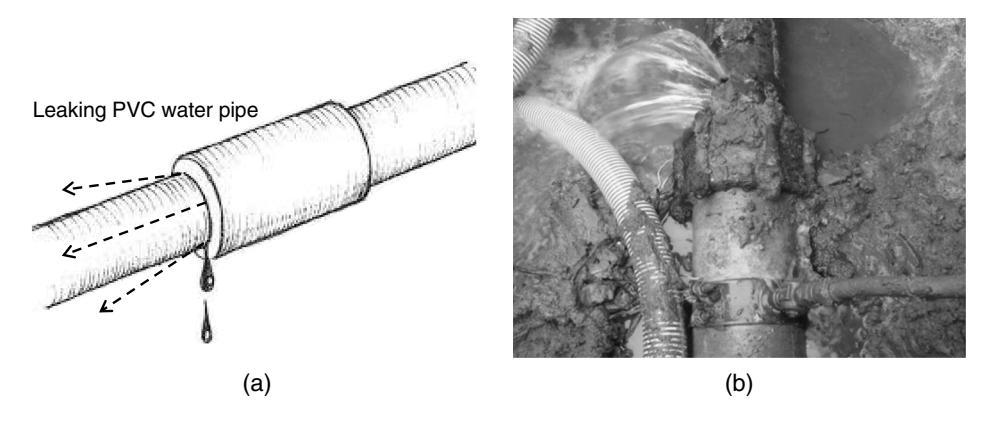
Fig. 1. (a) Example of potential leaks in a pipe; and (b) how it looks in a real situation.

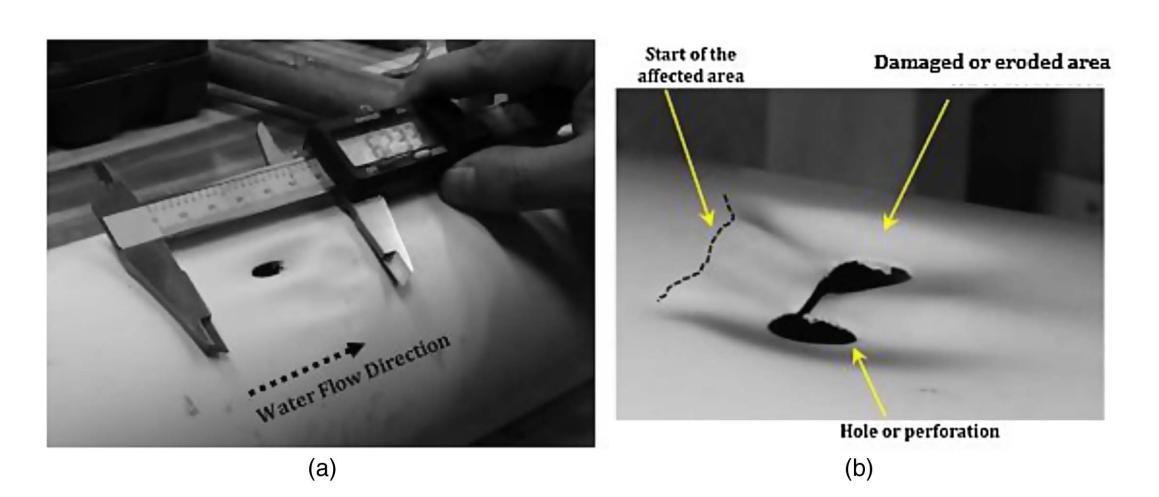
The results obtained from each test showed that failures were inevitable regardless of the surface material of the tested pipe, caused by the interaction of many input variables such as pressure, test time until failure, diameter, and wall thickness. All tested pipes presented scouring damage due to the impact of the simulated leakage jet and scouring of soil particles against the pipe. The deterioration process started with the weariness of the walls of the pipes caused

Fig. 7. (a) Failure measurements of PVC tested pipe; and (b) characteristics of scour damage seen.

by the water pressure coming out of the flute at a constant abrasion rate. In general, the behavior of the failures was very similar among tests, while there were differences in the size and location of the perforations.

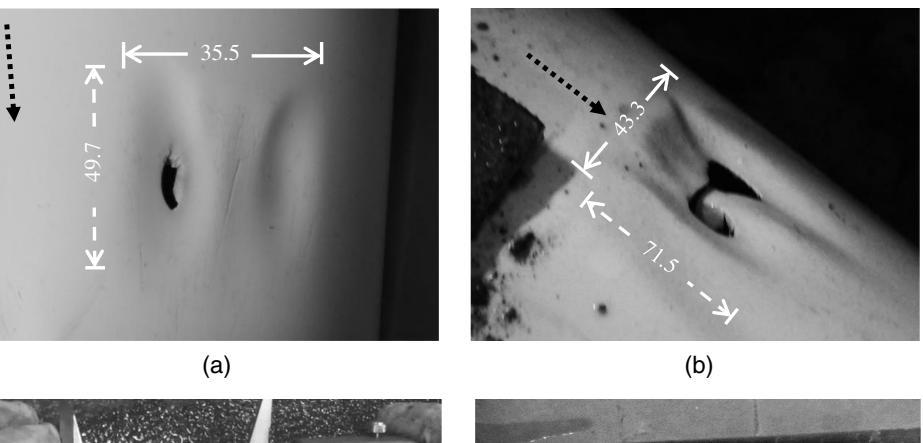
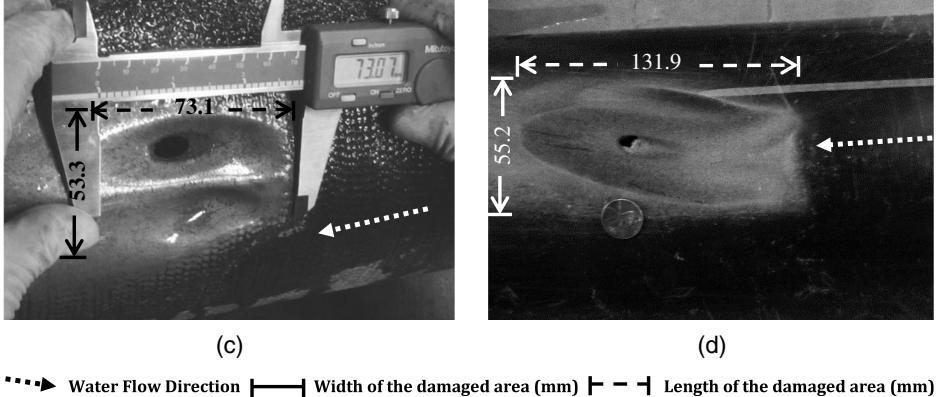
Fig. 8. Worn areas of different tested pipes.

Usually damage began close to the outlet of the flute and developed several centimeters downstream. The affected areas showed well-defined elongated shapes that tended to be oval and extended mainly in the direction in which the water jet was ejected. As seen before, some pipe tests (Tests 2, 4, 5, and 7) showed two valleys with a crest in the middle that had greater wall thickness, while in the other tests a single valley was formed. This damaged shape followed no detectable trend. For example, comparing results in Fig. 8, it can be seen that perforations did not always appear when two valleys were formed, and holes that would go through both valleys occurred even less frequently. There were two tests (Tests 3 and 8) where no perforations, and on the second attempt the perforation indeed appeared.

Furthermore, it is noteworthy that, in the case of ductile iron pipes, not only abrasion problems were recorded but also corrosion. This happened because the movement of the particles removed the protective coating of the pipes; therefore, water could come into contact with the metal wall and oxidation occurred.

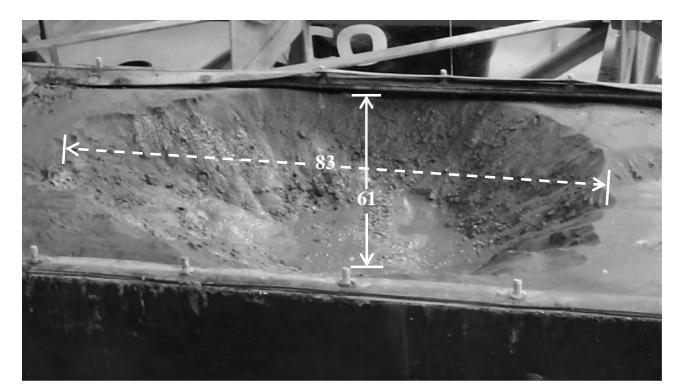
Another aspect to discuss is soil fluidization, which affects the soil arrangement and destabilizes the surrounding environment (Fig. 10). At first, an assumption was made that the bore in the soil surface was formed because the tank was not completely filled. However, after several trials it was observed that the water jet affected the structure of the granular material owing to soil fluidization.

Fig. 10. View of land subsidence in Test 5.

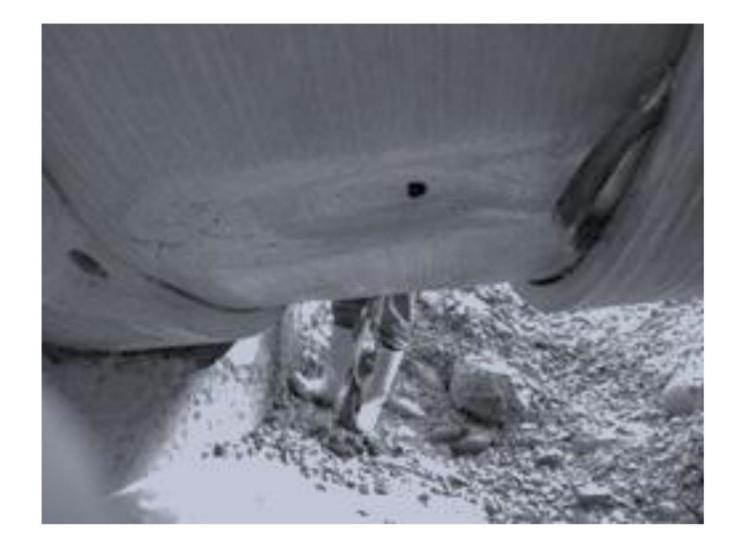
Fig. 12. External abrasion real case.

Finally, a real external abrasion case is shown in Fig. 12 that exhibits erosion characteristics very similar to what was found in laboratory tests. In this case, the pipeline was a GRP Pipe 2200 that was 272 mm in diameter with a wall thickness of 29 mm. The external abrasion was caused by Movement 273 of the O-ring seal under a pressure of 20 bar.
