External Abrasion Caused by Leakages in Potable Water Distribution System Pipes

Daniela Rojas¹; Kevin Vargas²; Andrés Cortés³; Sebastián Rocha⁴; Pablo París⁵; Viviana Riveros⁶; and Juan Saldarriaga, M.ASCE⁷

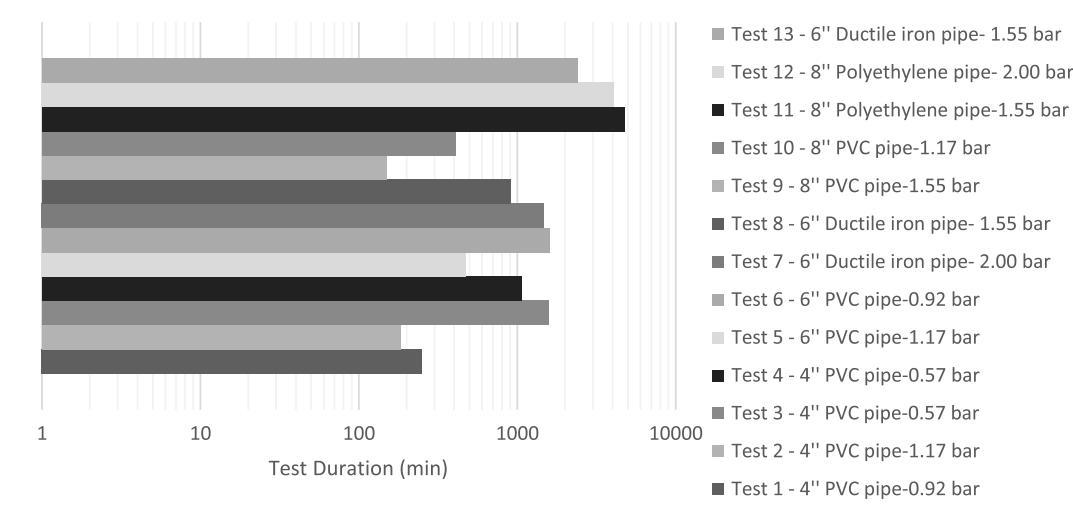
Fig. 9. Test duration for every test made.

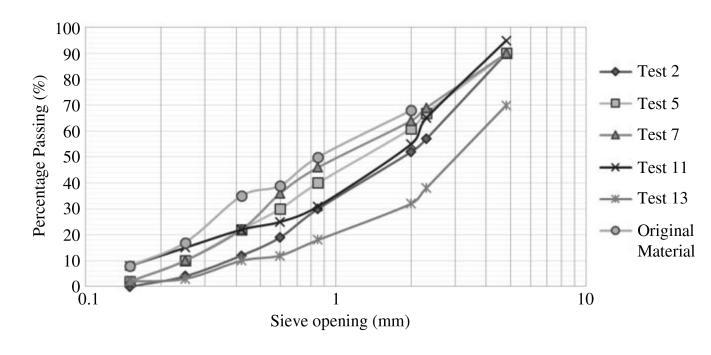
A significant amount of studies have been carried out on this topic, but the most relevant one for this research is the one by van Zyl et al. (2013). This research aimed to understand the effects of leaks (through orifices) in a water distribution pipe in the surrounding soil throughout several tests (van Zyl et al. 2013). During this process, the finest particles were washed out, and as time passed only material of larger particle size was found near the nozzle area. Granulometric analysis was conducted on the soil material that entered the test pipes through holes, assuming that it corresponded to the same type of sample as the one in the tank that remained near the nozzle of the flute. Indeed, Fig. 11 shows that

Fig. 11. Granulometric curves of material found in inner part of pipe at end of test and original mixture.
